# **THE ROLE OF MAGNESIUM IN CONCRETE DETERIORATION**

**Final Report  
November 1994**

**Iowa DOT HR-355**

**Robert D. Cody, Paul G. Spry,  
Anita M. Cody, and Guo-Liang Gan  
Department of Geological and Atmospheric Sciences  
Iowa State University  
Ames, IA 50011**

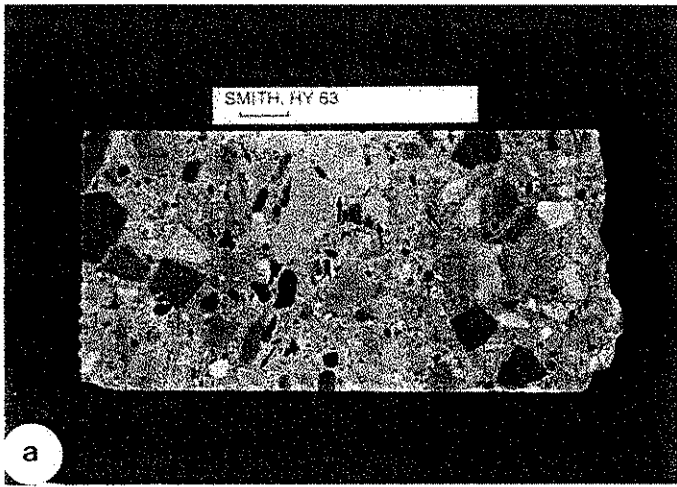
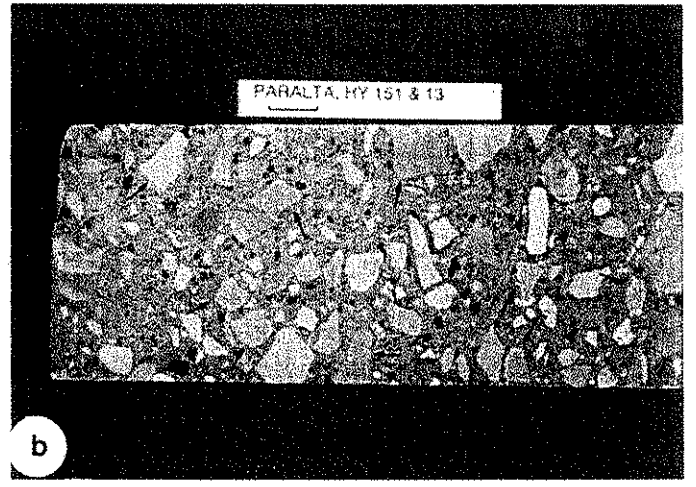
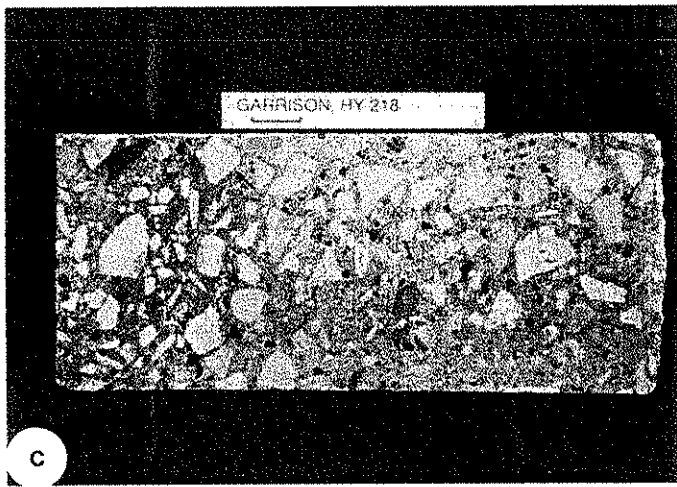
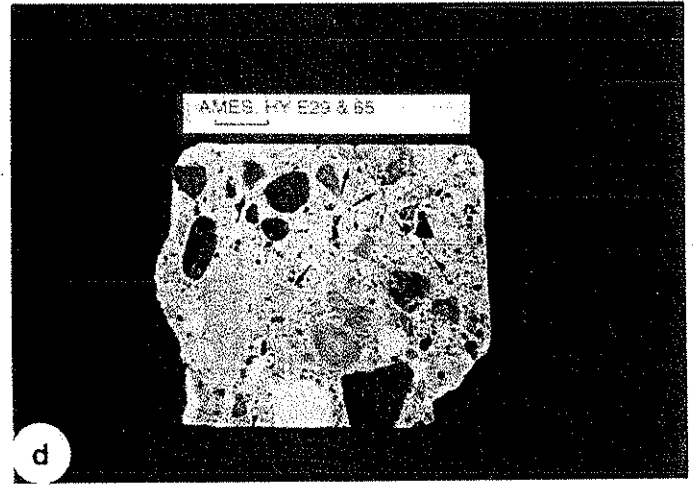
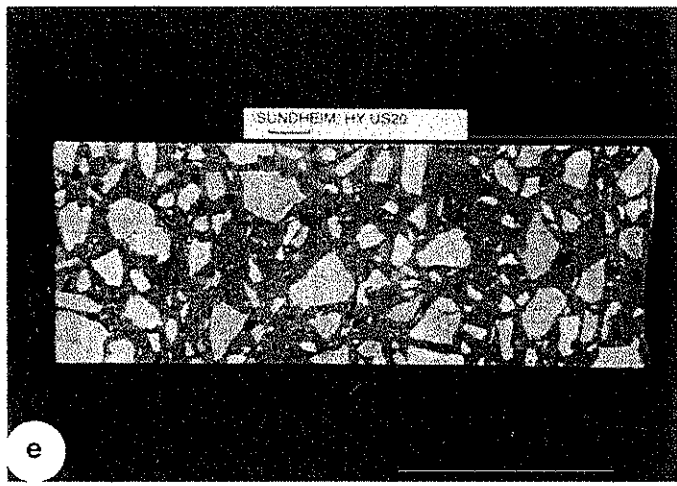
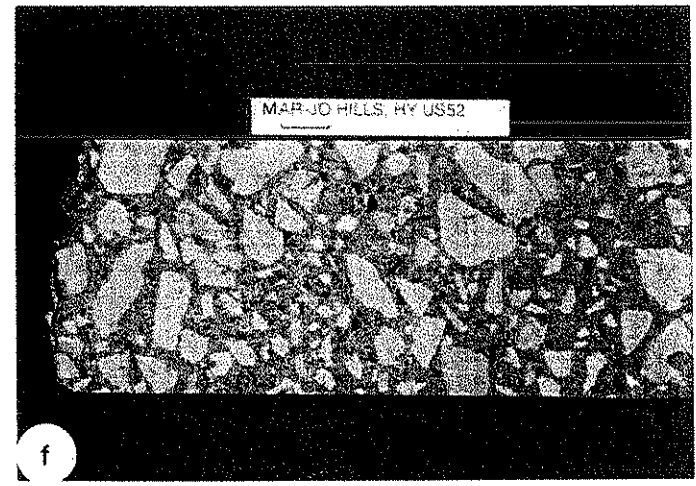
PLATE I

Plt I. Core samples of Iowa highway concrete. The concrete contains aggregates from the following quarries (a) Smith, (b) Paralta, (c) Garrison, (d) Ames gravel pit, (e) Sundheim, (f) Mar-Jo Hills. Service records are Smith: 12 yrs., Paralta: 8 yrs., Garrison: 12 yrs, Sundheim: > 40 yrs., and Mar-Jo Hills: > 40 yrs. Arrows indicate that non-durable concretes (those with short service lives) with aggregate from Smith, Paralta, Garrison, and Ames pit quarries show more pronounced reaction rims and micro-cracks than durable (long service lives) Sundheim and Mar-Jo Hills concretes. Bars = 2 cm.

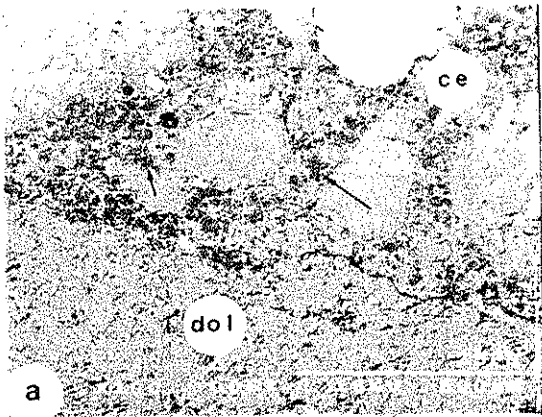
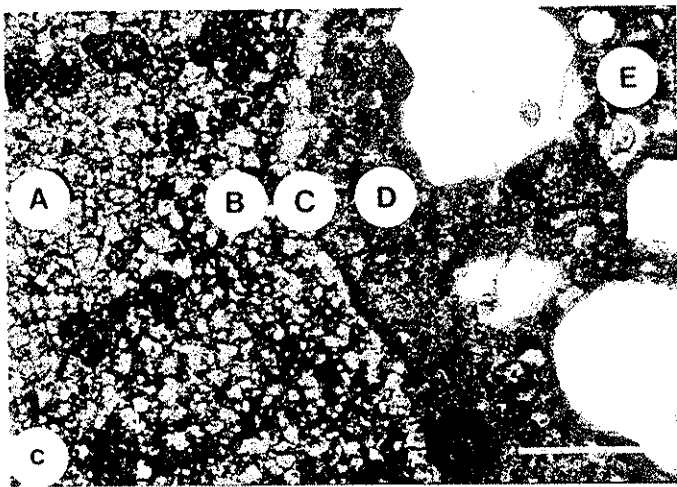
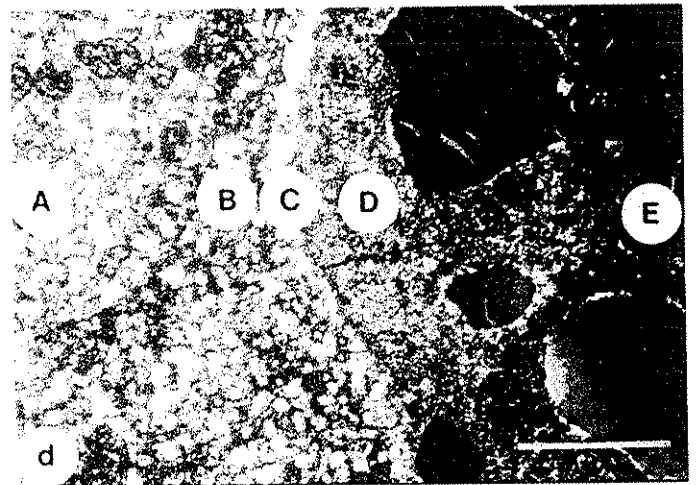
PLATE III

Boundaries between the different zones are gradational except for that between zones C and D. Compared to zone A, zone B is more porous, and zone C is less porous. In SEM view, Zone D is brighter (whiter) than zone E. Most interstitial voids in zone C are filled with white Ca-rich minerals which decrease in abundance from aggregate-paste interface toward the unaltered paste, Zone E. More micro-cracks are visible in zone E than in zone D, and some air voids in E are partially filled with secondary materials. Figs 1,2 are electron microprobe traverses and EDAX elemental maps of the area shown in IIIe, whereas Figs 3,4 are of area shown in IIIf.

The cement paste shows major textural differences between durable and non-durable concretes. Small concentric-laminated, spherical bodies are common in the durable concrete pastes (Plt IIIa), whereas they are almost lacking in the non-durable pastes. These bodies are composed of hydrated cement phases. In the non-durable paste, abundant highly-fractured spherical to subspherical mineral grains without concentric structures occur (Plt IIIb). These grains also are probably a portland cement mineral phase, but their appearance is strikingly different than those in the durable concretes.

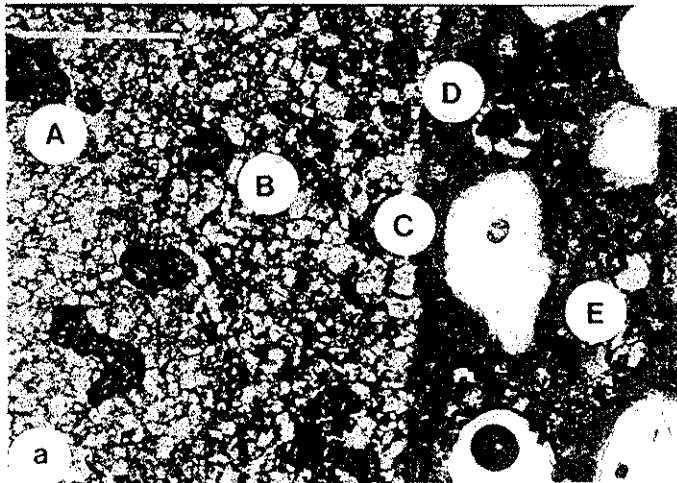
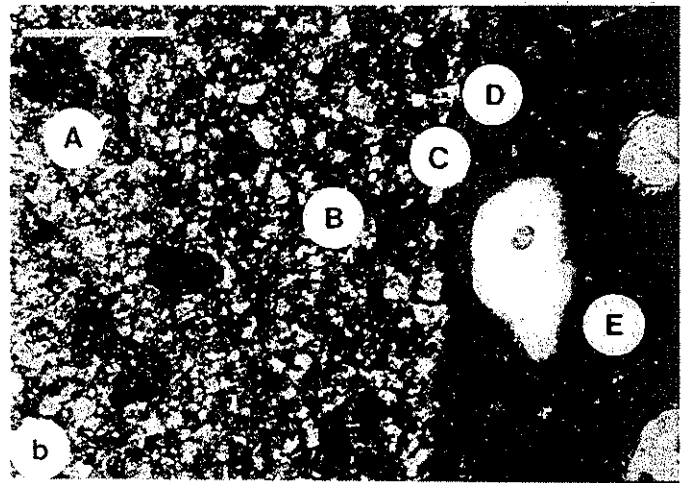
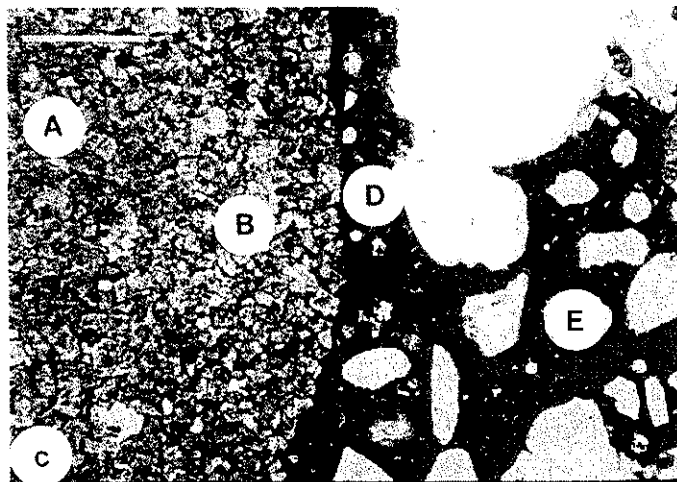
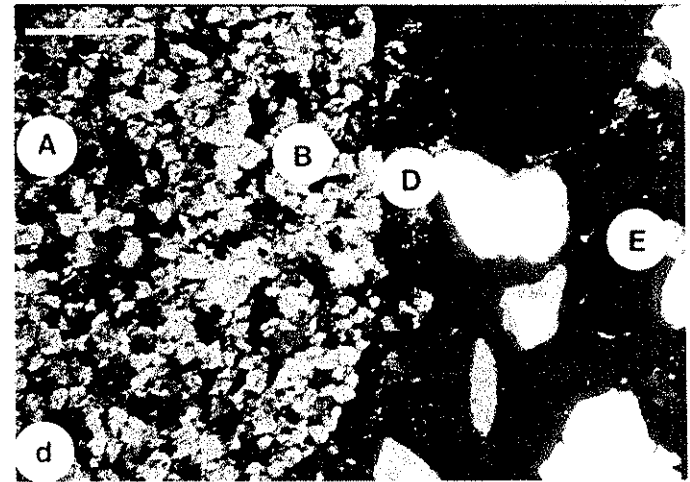
PLATE IV

Plt IV. Light and SEM micrographs of Smith quarry concrete and Paralta quarry concrete.

Note the variable width of the light-colored cement paste rim, zone D, the high porosity of the inner region of the dark dolomite rim, zone B, and the reduced porosity of the outer part of zone B. Interstitial voids have been filled with secondary minerals. Between the more porous inner part and less porous outer part of the dark dolomite rim, B, there is a crack which is parallel to the aggregate edge. The crack is filled minerals that appear white and gray in SEM views. There are many micro-cracked grains in the cement paste, as indicated by arrows. Refer to Fig 5 for EDAX maps of area.

**Type II Rim Sequence.** This sequence is found in those aggregate particles lacking the light-colored dolomite rim, and is evident on a second aggregate particle in the Paralta quarry concrete core (Fig 3, Plt IVc-f and Va-f). Our analyses reveal this type of aggregate is most common in the non-durable concretes studied here. In the sample containing Paralta quarry aggregate, the dark dolomite rim is thick and well-defined both visually and chemically (zone B, Fig 6). The microprobe traverse reveals a significant increase in CaO with a corresponding decrease in MgO within the dark dolomite rim compared with the unaltered interior dolomite (Fig 6). Both  $\text{Na}_2\text{O}$  and  $\text{K}_2\text{O}$  (Fig 3b), and  $\text{Al}_2\text{O}_3$  (Fig 3c) often increase within the dark rim, whereas FeO often remains almost constant from aggregate interior through to the dark dolomite rim.

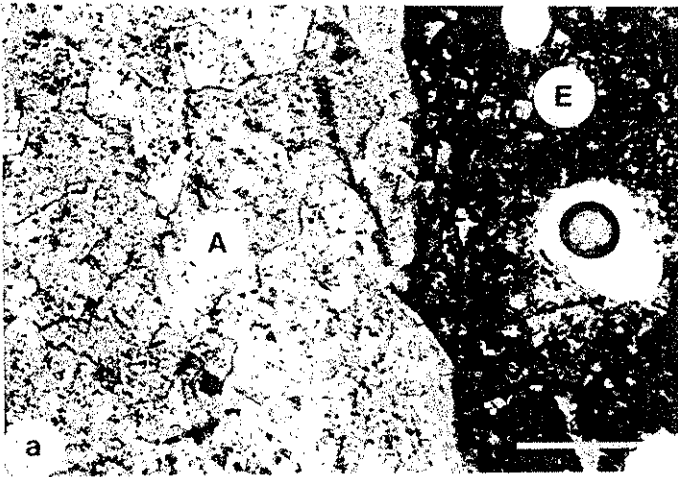
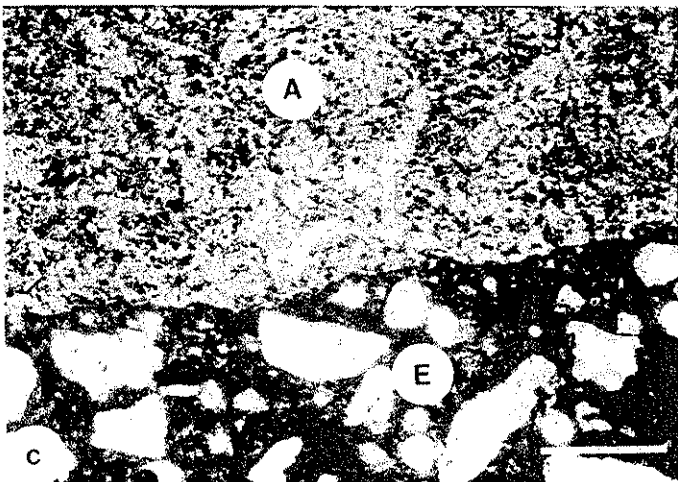
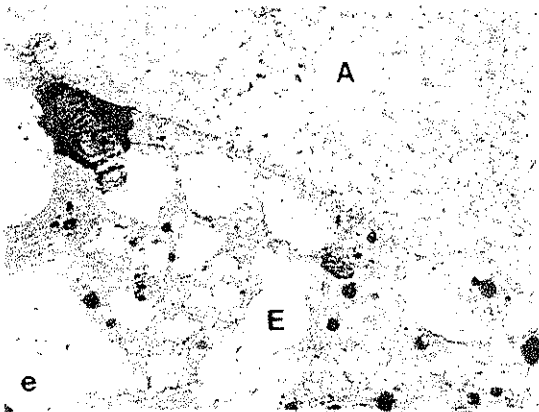
PLATE VI

- e. SEM micrographs of durable Sundheim quarry concrete traversed by electron microprobe in Fig 11 and shown in EDAX element maps, Fig 12.
- f. SEM micrograph, enlargement of nodular section in center previous micrograph, Plt VIe. No reaction rim is visible in aggregate or cement paste, and only a very few micro-cracks are visible in the paste. Fig 12 gives corresponding EDAX mapping.

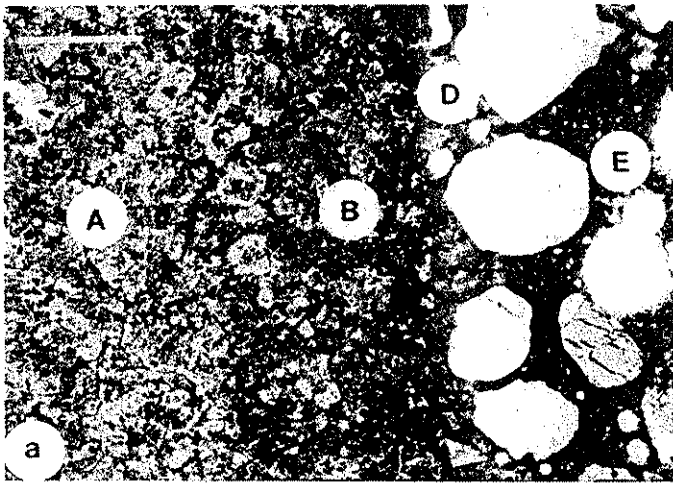
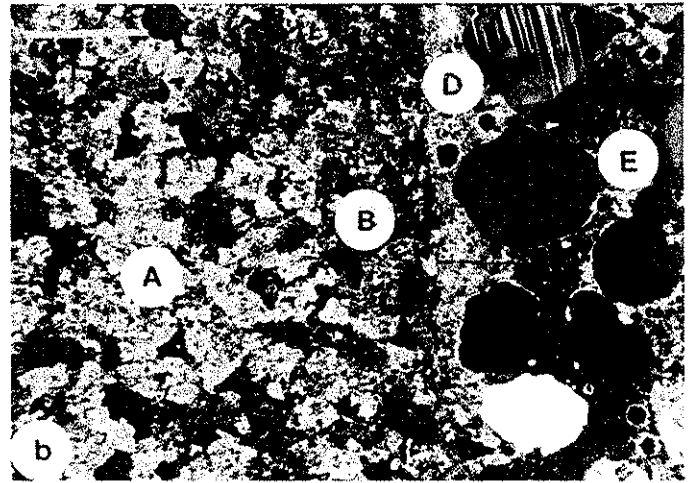
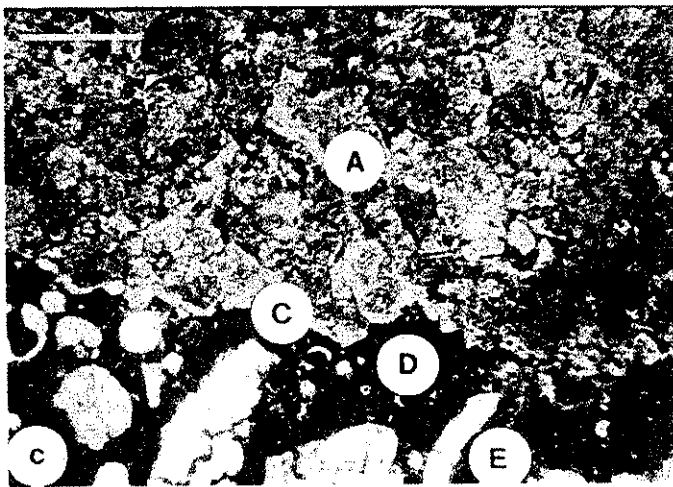
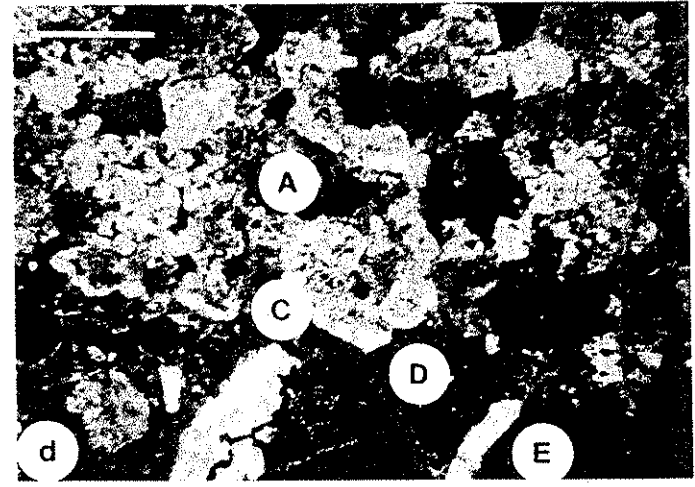
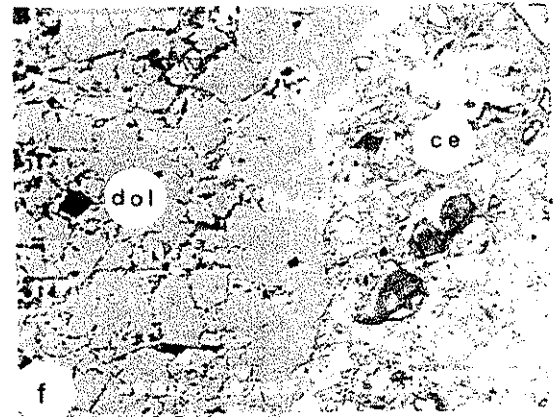
PLATE VII

Plt VII. Light and SEM micrographs of durable Mar-Jo Hills and Sundheim and non-durable Smith quarry concretes.

f. SEM micrograph of Smith quarry concrete, showing aggregate-paste boundary, and high porosity. Fig 17 gives corresponding EDAX maps.

In a few aggregate grains discolored reaction rims can be seen at the interface of both dolomite aggregate and cement paste (Figs 14 -15; Plates VIIa-f). These rims resemble those found in the non-durable concretes. Dark or light dolomite rims may be visible, but both rims do not typically occur together. Often these rims, particularly the thin, light dolomite rims, are discontinuous and extend only partly around an aggregate particle.

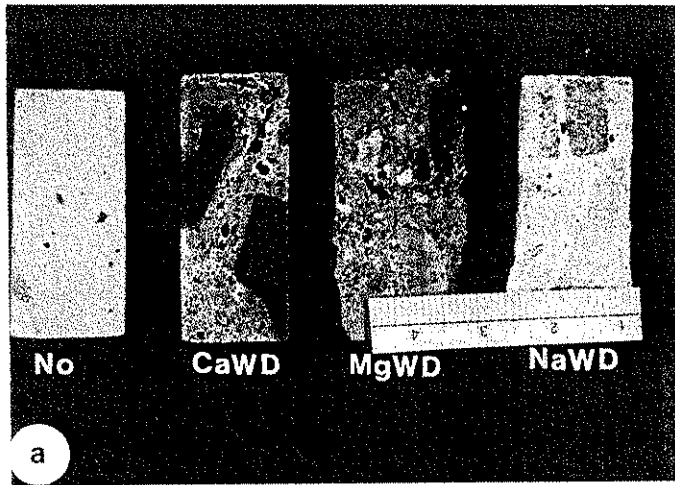
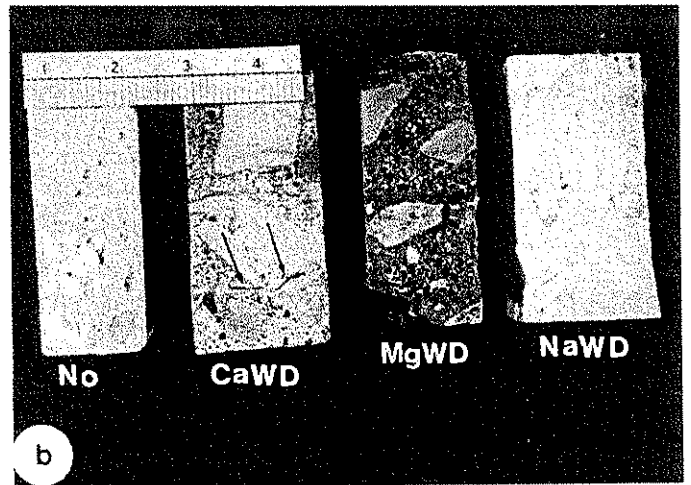
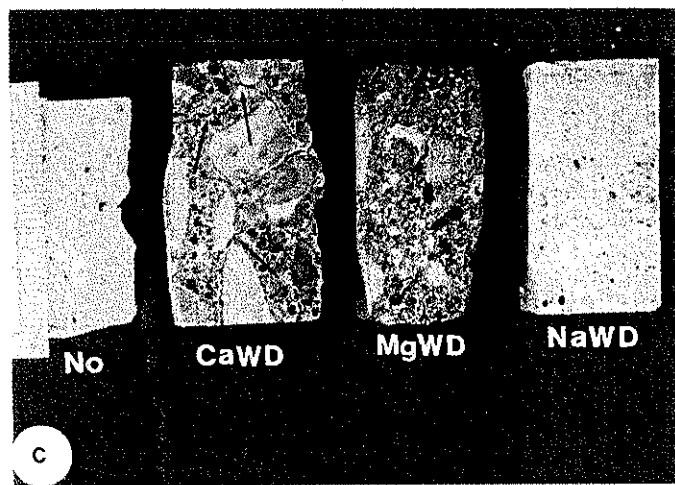
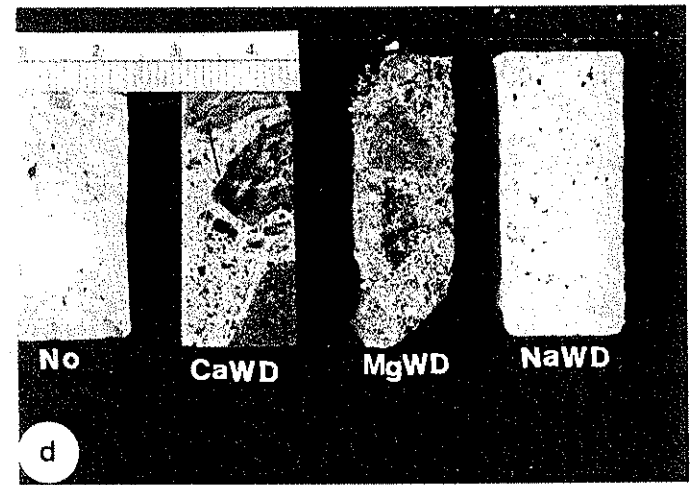
PLATE VIII

Plt VIII. Experimentally-produced deterioration of Iowa highway concrete. The concretes contain aggregates from (a) Smith, (b) Paralta, (c) Garrison, (d) Ames gravel pit, (e) Sundheim, and (f) Mar-Jo Hills quarries.

All of the concretes exhibited marked cracks (arrows) and browning paste discoloration from CaWD cycles. All concretes exhibited severe crumbling and decomposition, and dark brown paste discoloration wet/dry cycling in magnesium whereas concretes showed little deterioration from Na wet/dry cycling. No = no treatment, CaWD, MgWD, and NaWD = wet/dry cycling with 3M  $\text{CaCl}_2 \cdot 2\text{H}_2\text{O}$ ,  $\text{MgCl}_2 \cdot 6\text{H}_2\text{O}$ , and NaCl solutions, 60°C immersion and 90°C drying. Bar scale in cm and mm.

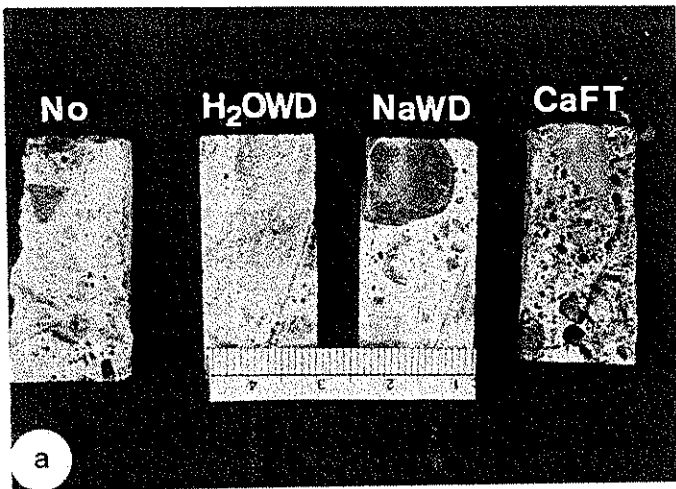
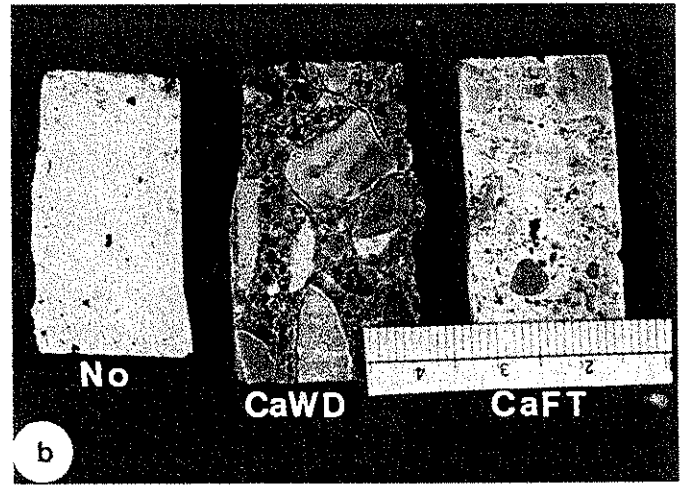
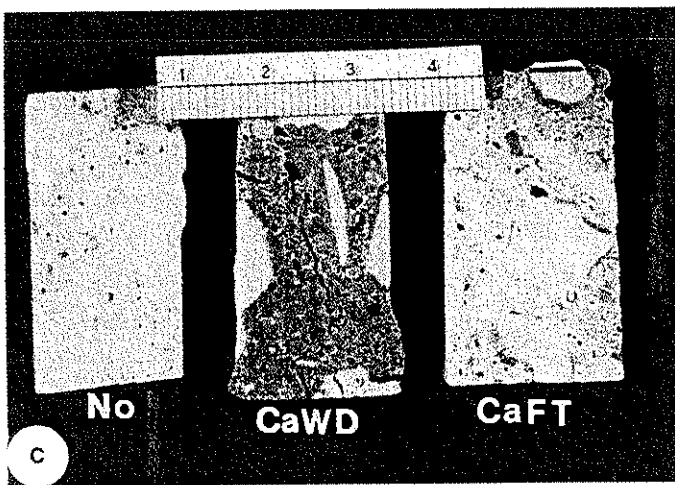
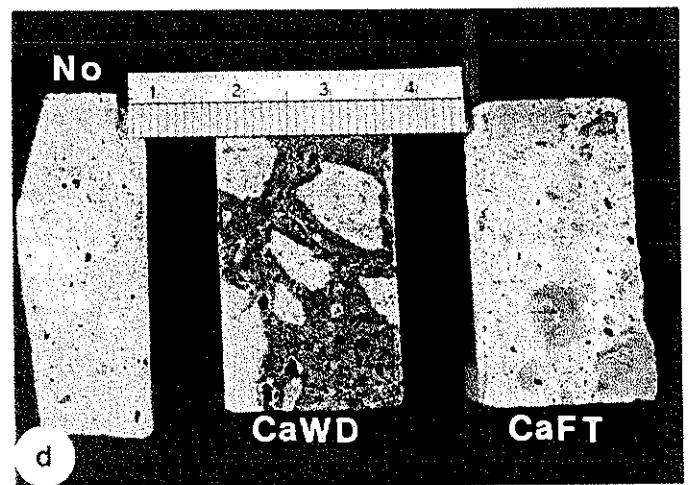
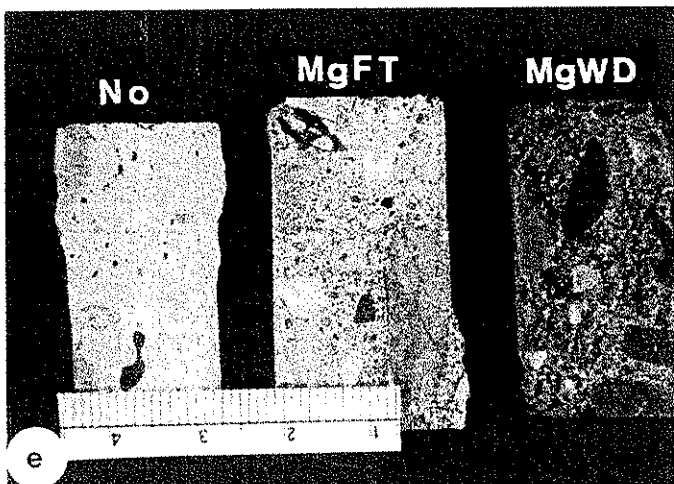
PLATE IX

Plt IX. Experimentally-produced deterioration of concrete containing Smith, Garrison, Sundheim, and Mar-Jo Hills dolomite coarse aggregate.

Essentially no deterioration was observed from wet/dry cycles in water or NaCl solutions. All concretes exhibited a slight brown discoloration of cement paste in  $\text{CaCl}_2 \cdot 2\text{H}_2\text{O}$  with freeze/thaw cycling, and all exhibited severe crack development and dark brown paste discoloration after Ca wet/dry cycling. Severe decomposition and dark paste discoloration was evident from cycling between wet/dry and freeze/thaw conditions in  $\text{MgCl}_2 \cdot 6\text{H}_2\text{O}$  solutions.  $\text{H}_2\text{OWD}$  = wet/dry cycling at  $60^\circ\text{C}/90^\circ\text{C}$  in distilled water;  $\text{NaWD}$  = same but with 3M NaCl solution;  $\text{CaFT}$  = freeze/thaw, with freezing at  $-70^\circ\text{C}$ , thawing at  $25^\circ\text{C}$ , and solution immersion at  $60^\circ\text{C}$ , 3M  $\text{CaCl}_2 \cdot 2\text{H}_2\text{O}$ ;  $\text{No.}$  = no treatment;  $\text{MgWD}$  and  $\text{MgFT}$  refers to identical experimental conditions but with 3M  $\text{MgCl}_2 \cdot 6\text{H}_2\text{O}$ .

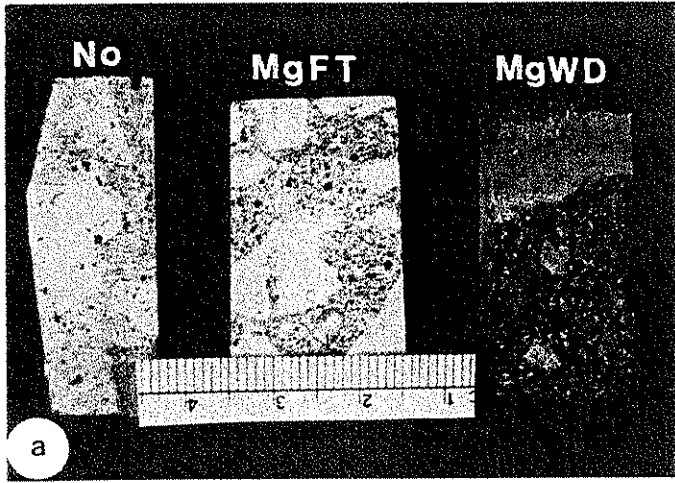
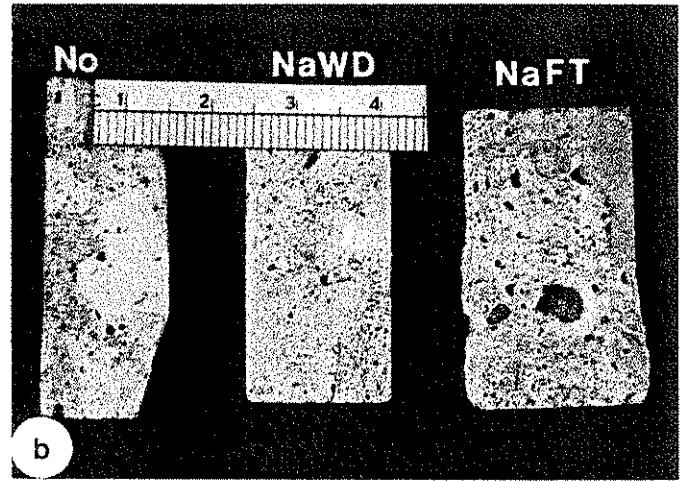
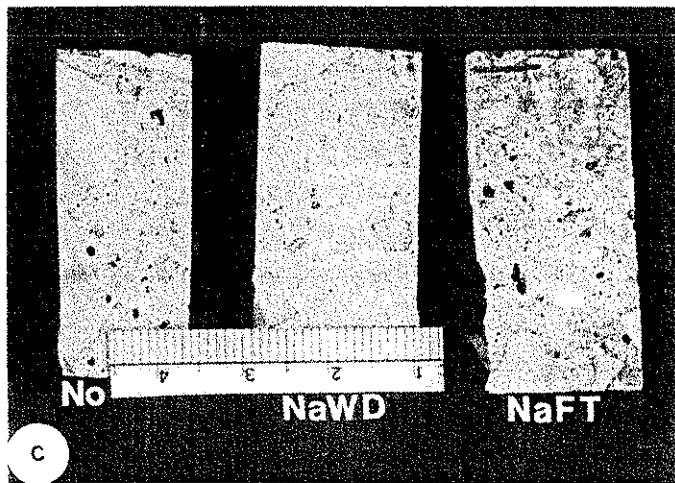
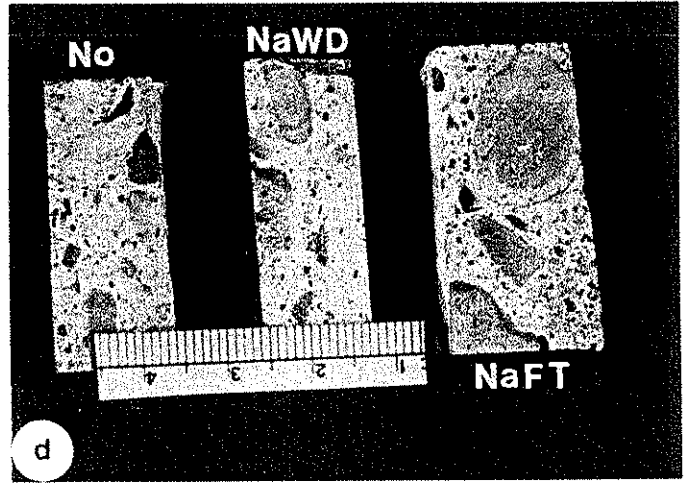
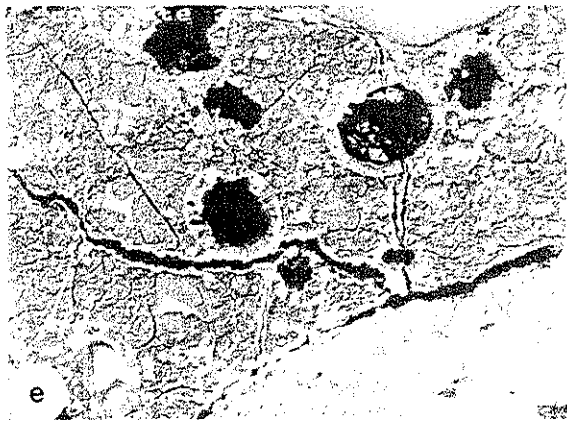
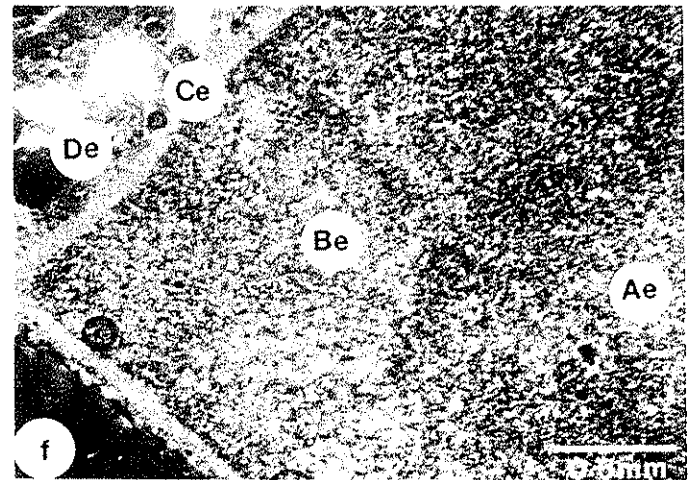
PLATE X

Plt X. Experimental deterioration of concretes and micrographs of treated materials.

Refer to Plt. IIIc-d for similar rim development in untreated concrete.

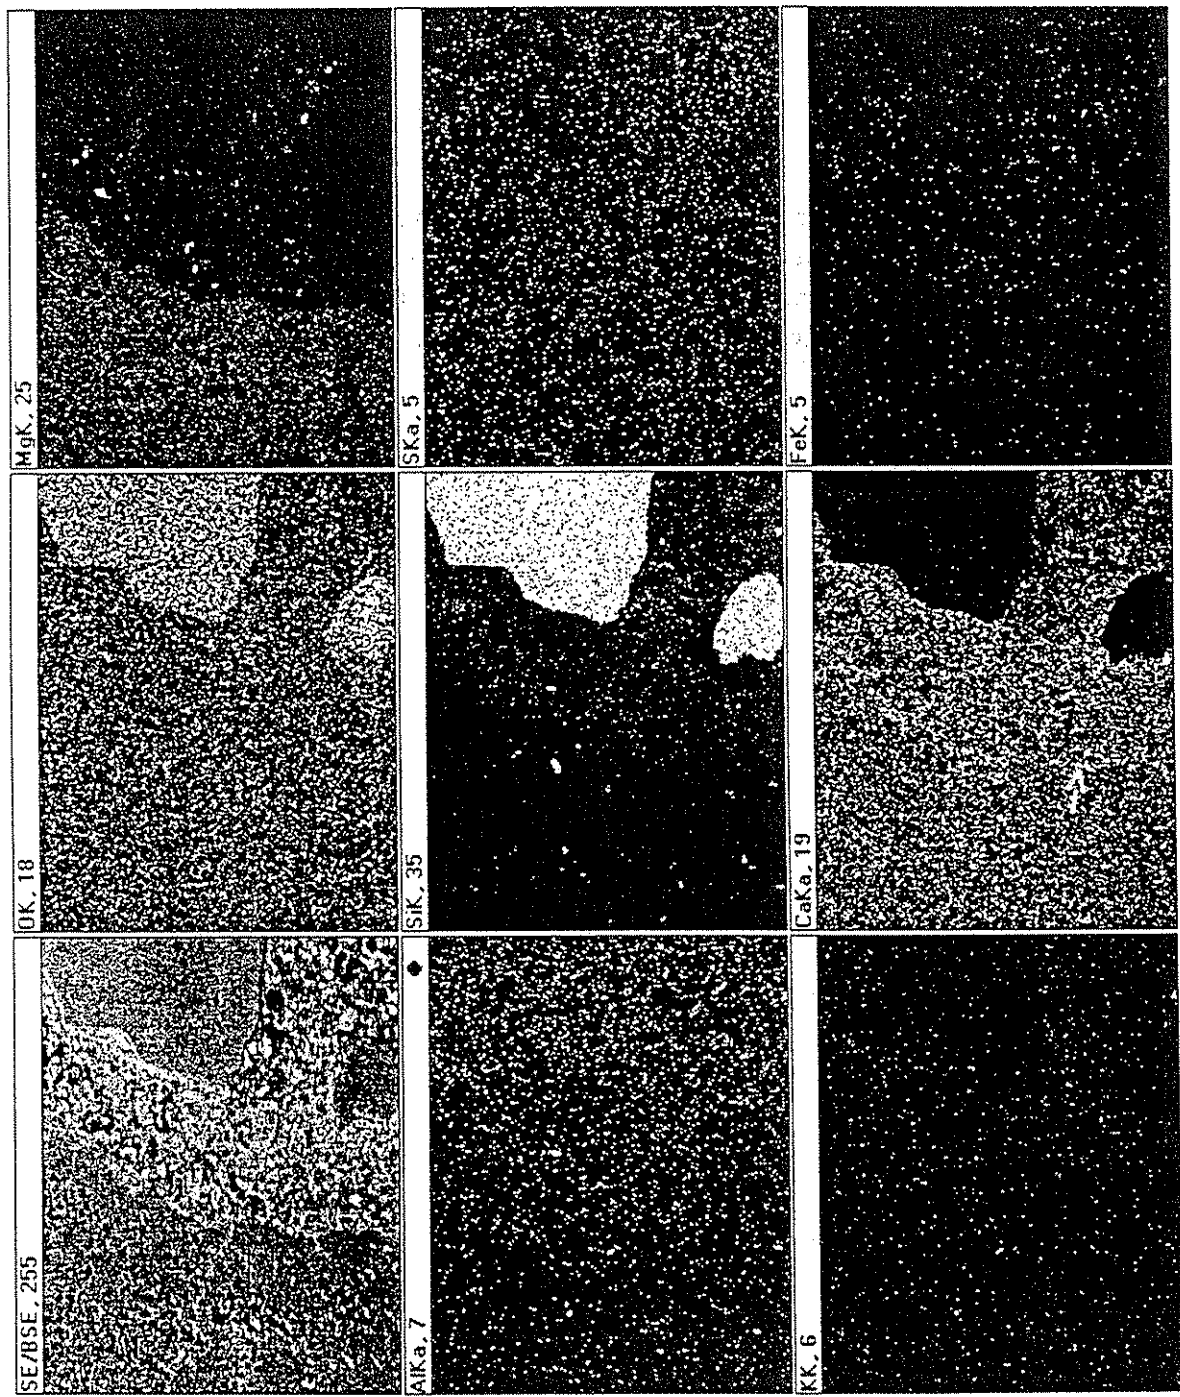
Figure 2

Fig 2. EDAX element maps of Smith quarry concrete.

Although not very clear, the high Ca region of D, Fig 1, is visible and is indicated by arrow. Mg and O concentrations probably indicate brucite crystals. Plt IIIc,d show corresponding light micrographs.

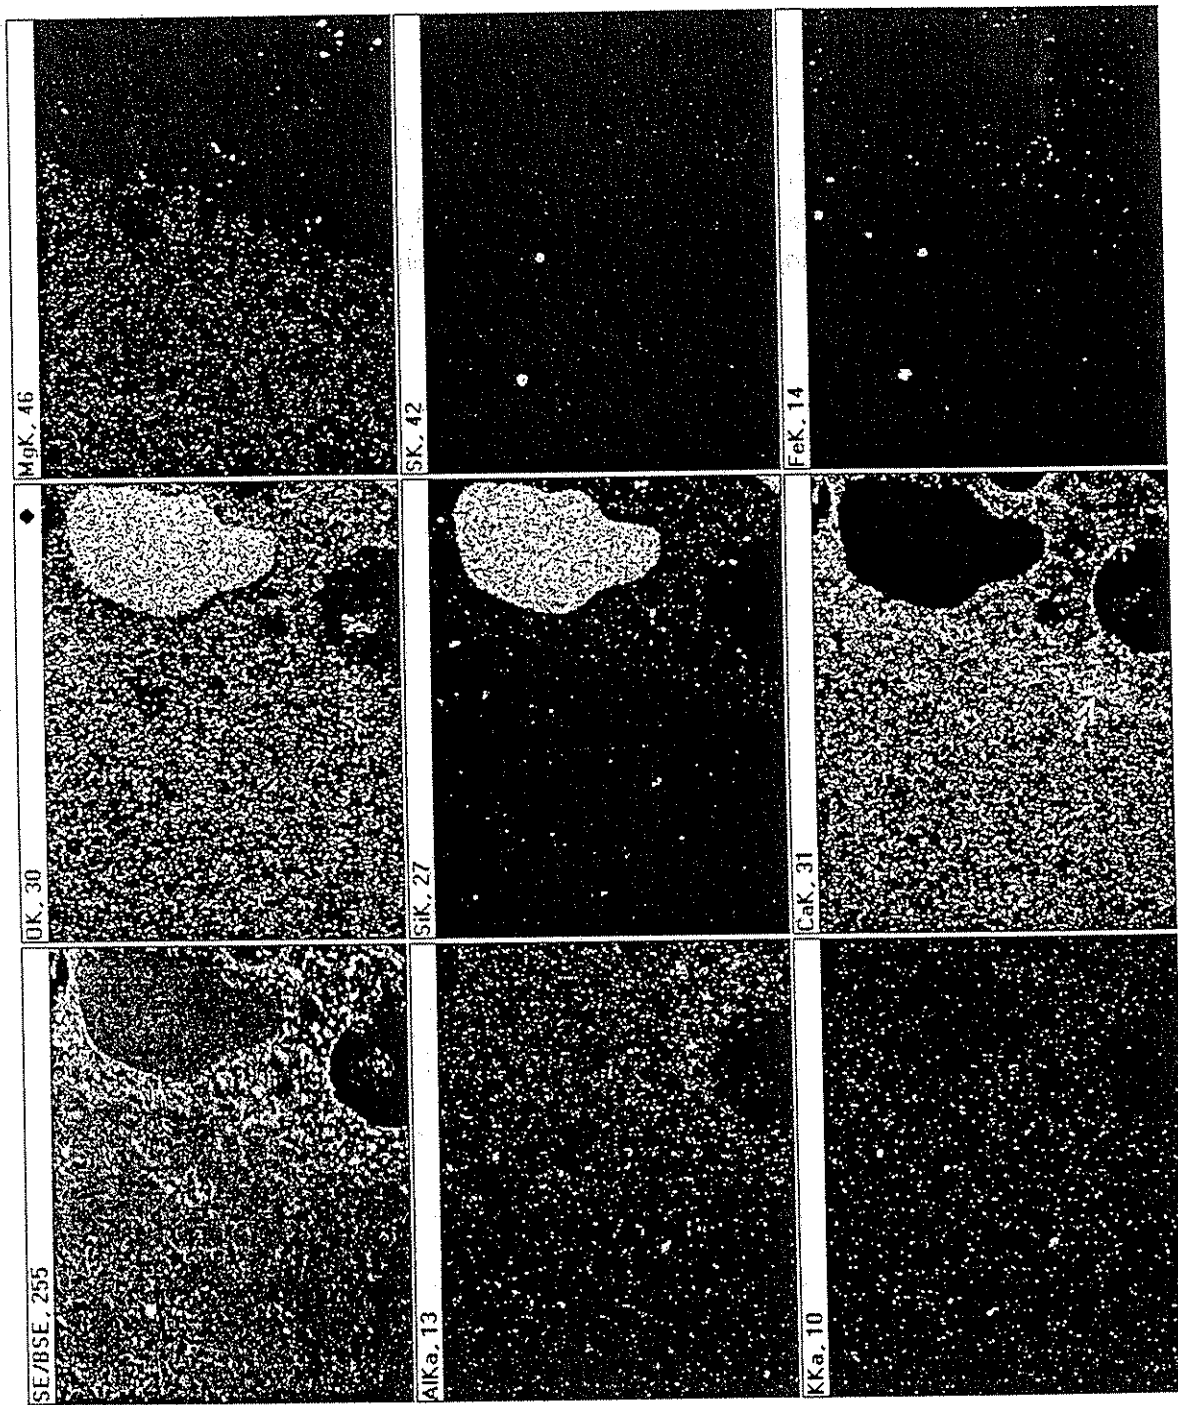
Figure 4

Fig 4. EDAX element maps of Smith quarry concrete.

Arrow indicates enrichment in CaO that is especially evident in D, the light-colored paste rim

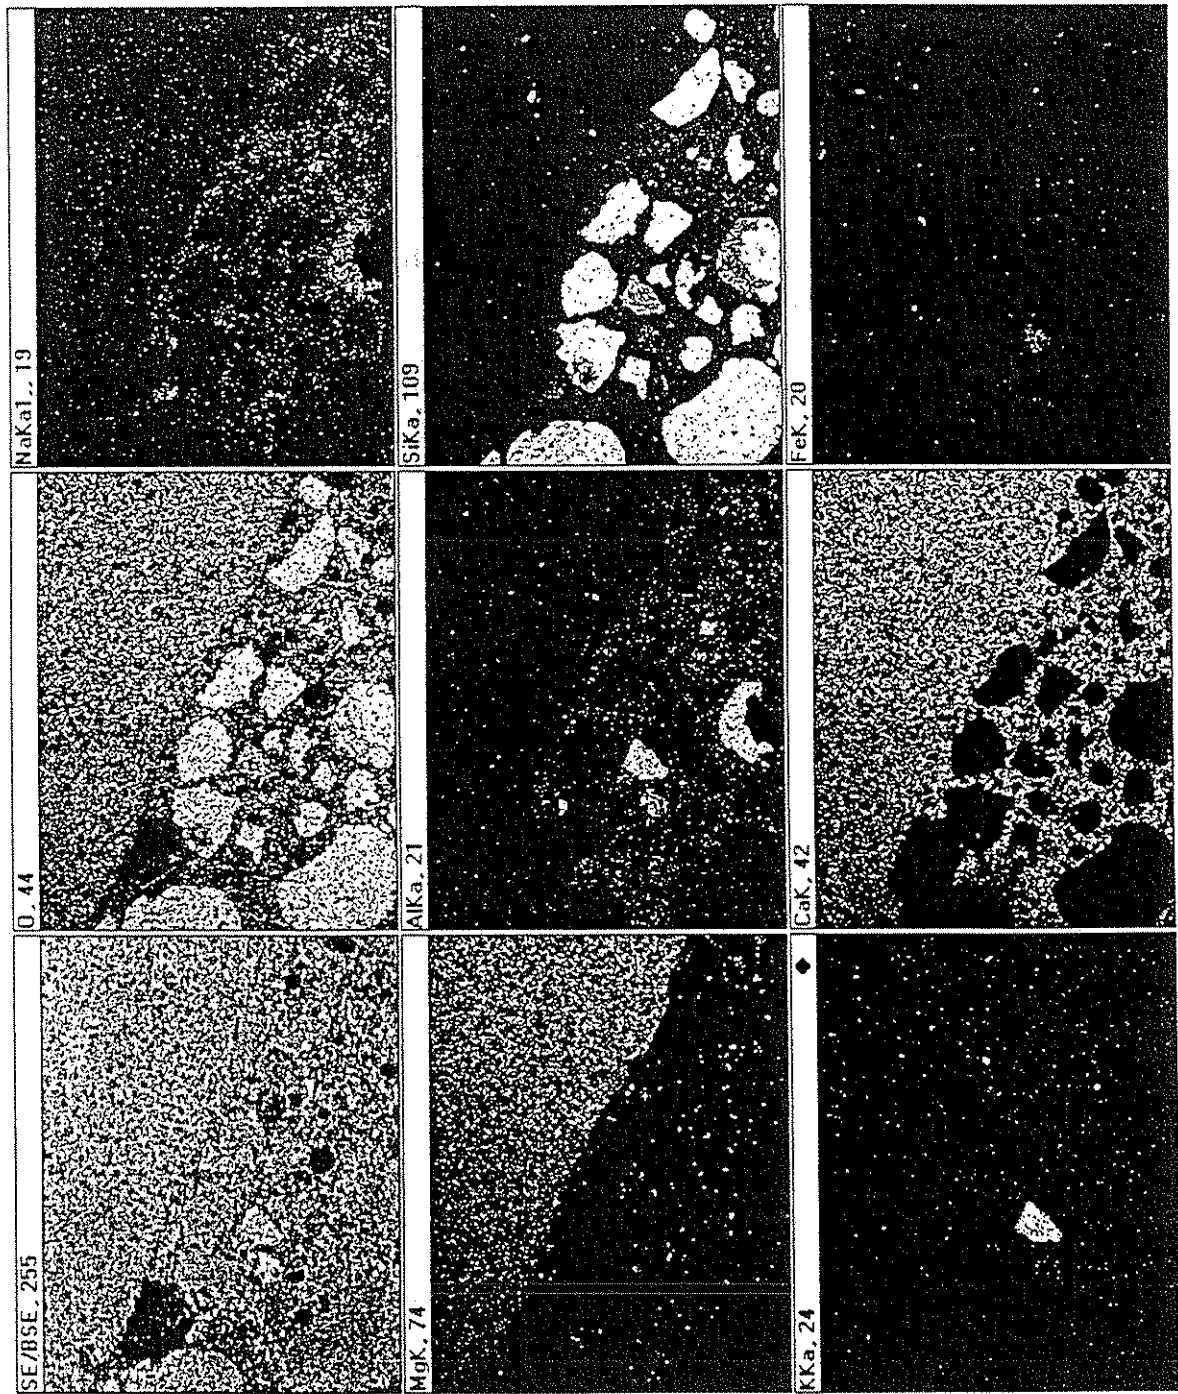
Figure 12

Fig 12. EDAX element maps of durable concrete containing Sundheim aggregate.

Both the dolomite aggregate and the cement paste are much more uniform in composition than the corresponding phases in non-durable concretes. Small Si-rich dots in dolomite indicate quartz inclusions, and Mg-rich dots indicate brucite. Plt VIe shows an SEM view and Plt VIc,d shows corresponding light micrographs of area of maps.

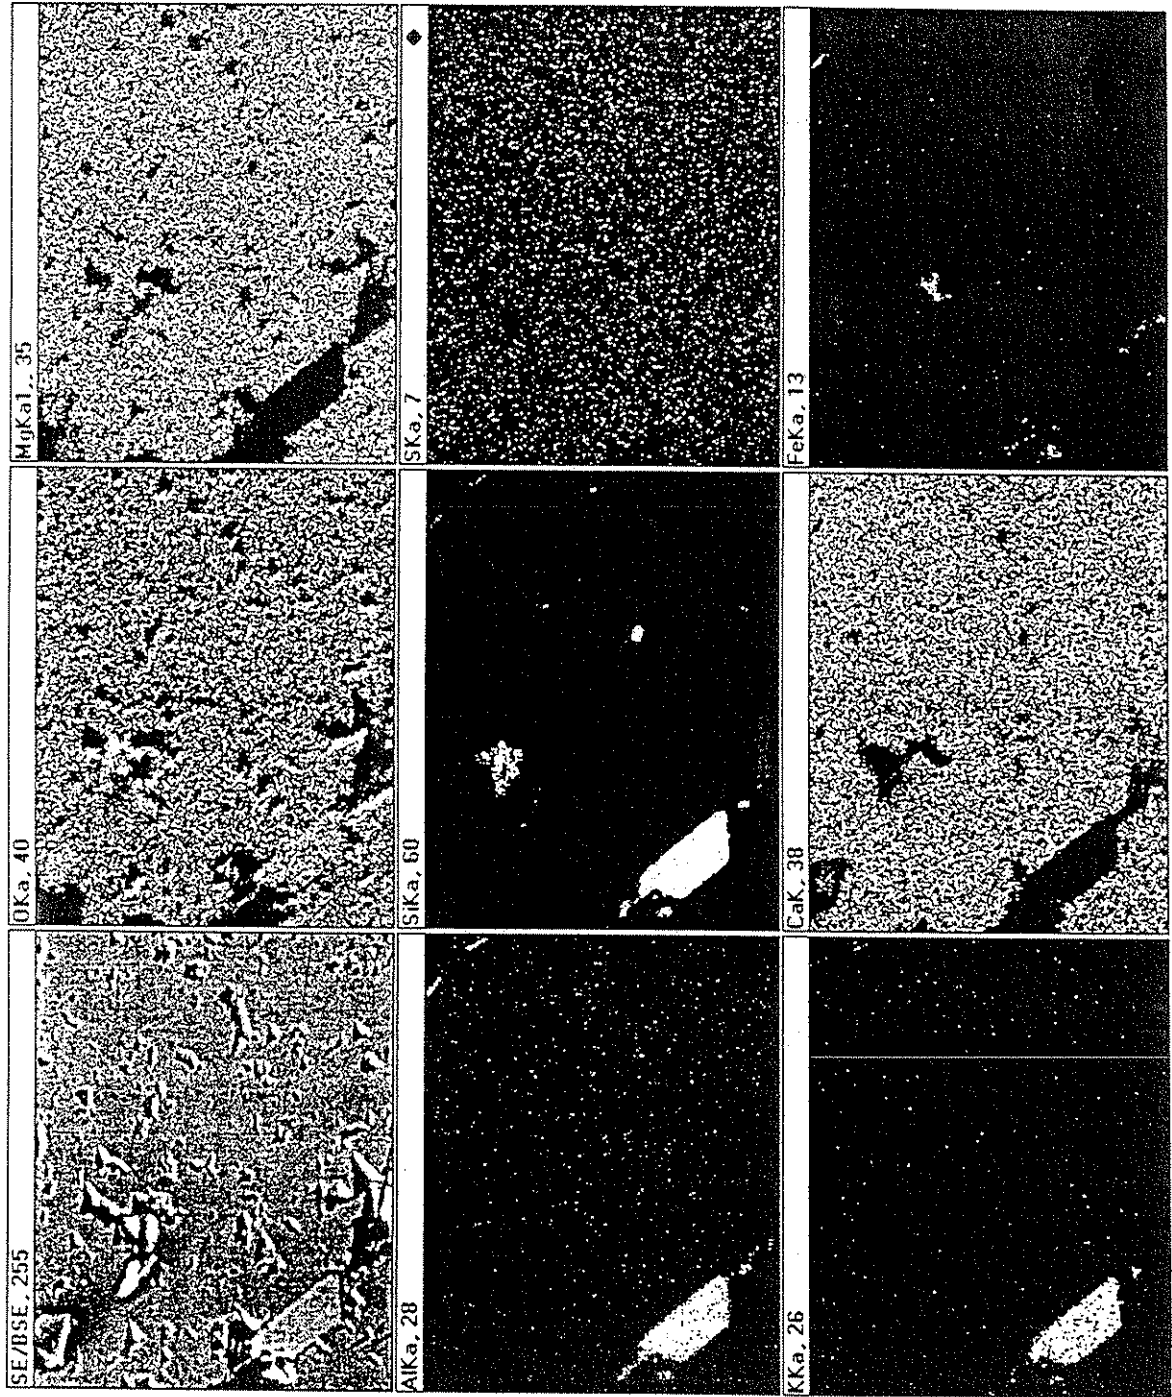
Figure 16

Fig 16. EDAX element maps for concrete containing Mar-Jo Hills quarry aggregate.  
SEM photograph of area is shown in Plt VIIe.

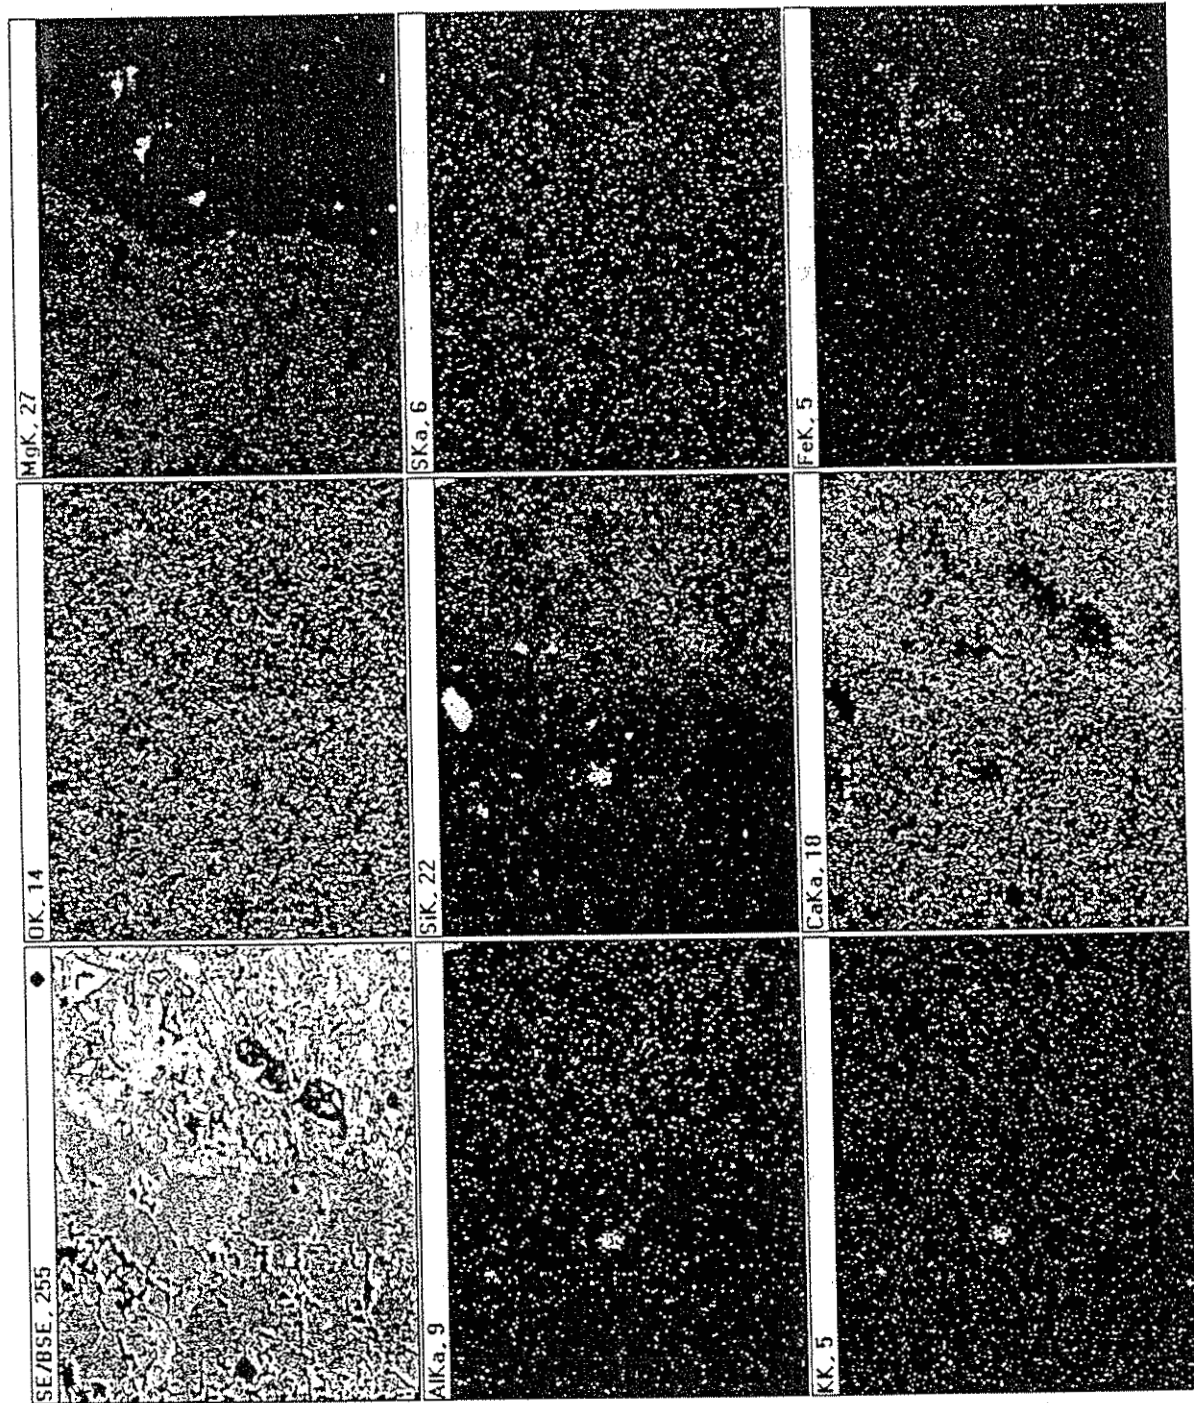
Figure 17

Fig 17. EDAX element maps for concrete containing Smith quarry aggregate.  
SEM photograph of area is shown in Plt VIIIf.
