# **THE ROLE OF MAGNESIUM IN CONCRETE DETERIORATION**

**Final Report  
November 1994**

**Iowa DOT HR-355**

**Robert D. Cody, Paul G. Spry,  
Anita M. Cody, and Guo-Liang Gan  
Department of Geological and Atmospheric Sciences  
Iowa State University  
Ames, IA 50011**

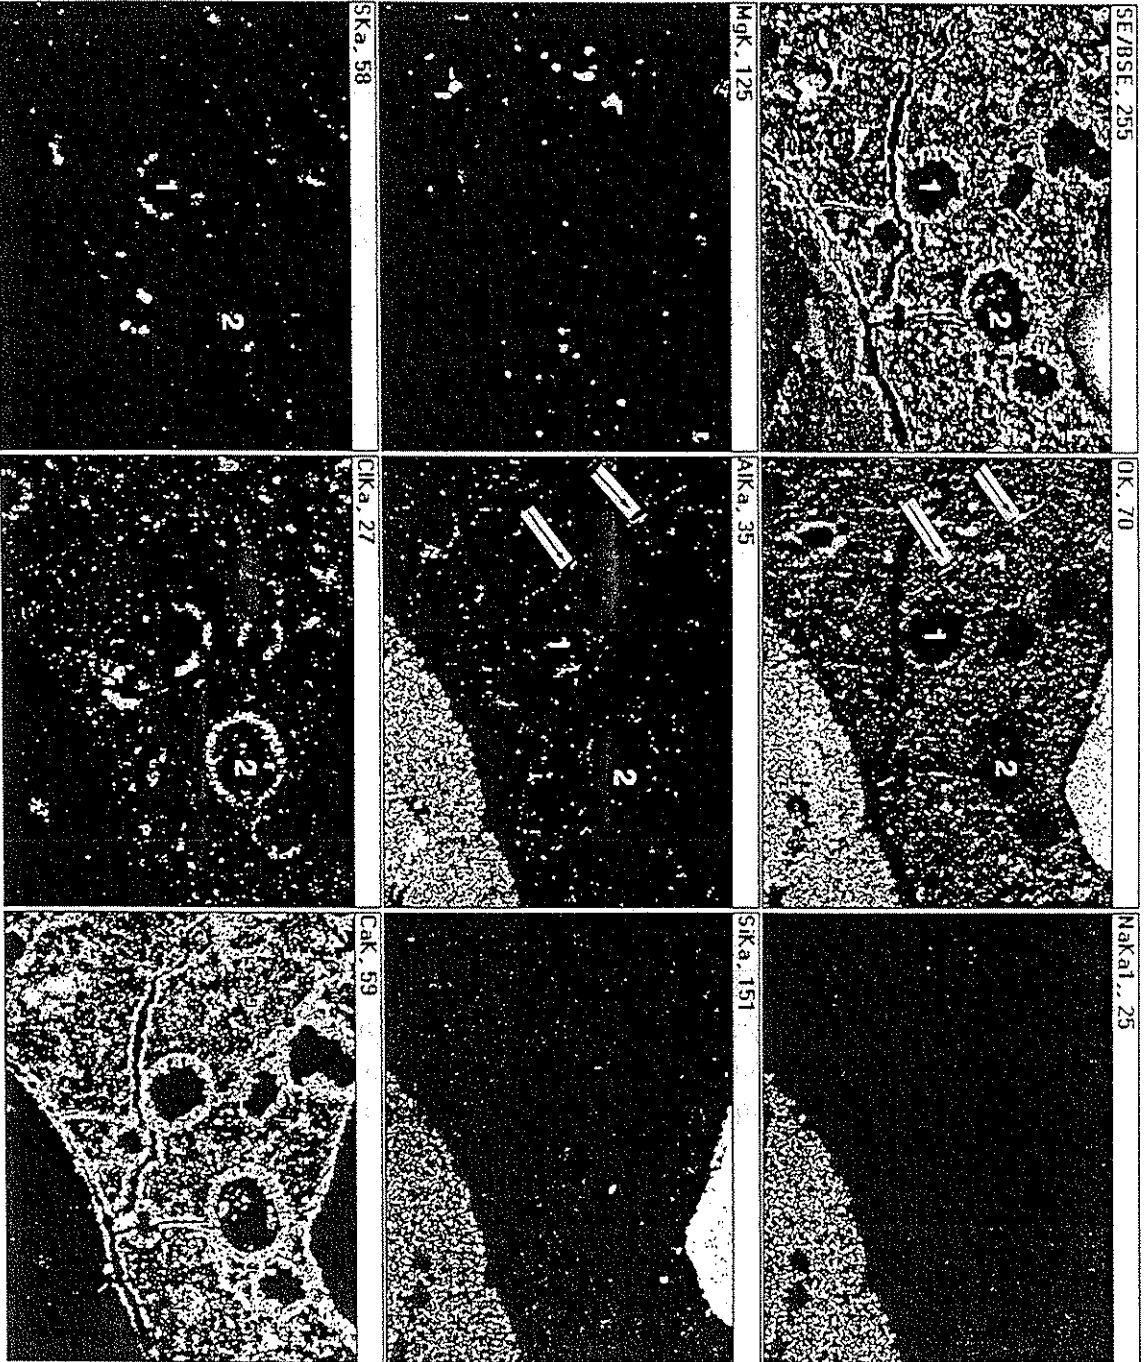
Figure 18

Fig 18. Experimental decomposition of concrete. EDAX element maps of concrete containing Garrison quarry aggregate after wet/dry cycling in Ca solution. Abundant Ca-chloride and Al + O crystals line void 2 and upper part of void 1. Ca + S + O (gypsum?) fills lower part of void 1. Brucite and probable calcite occurs in the paste. Crack-filling minerals are calcite, and also an Al + O mineral (arrows). Plt Xe shows equivalent SEM photograph.

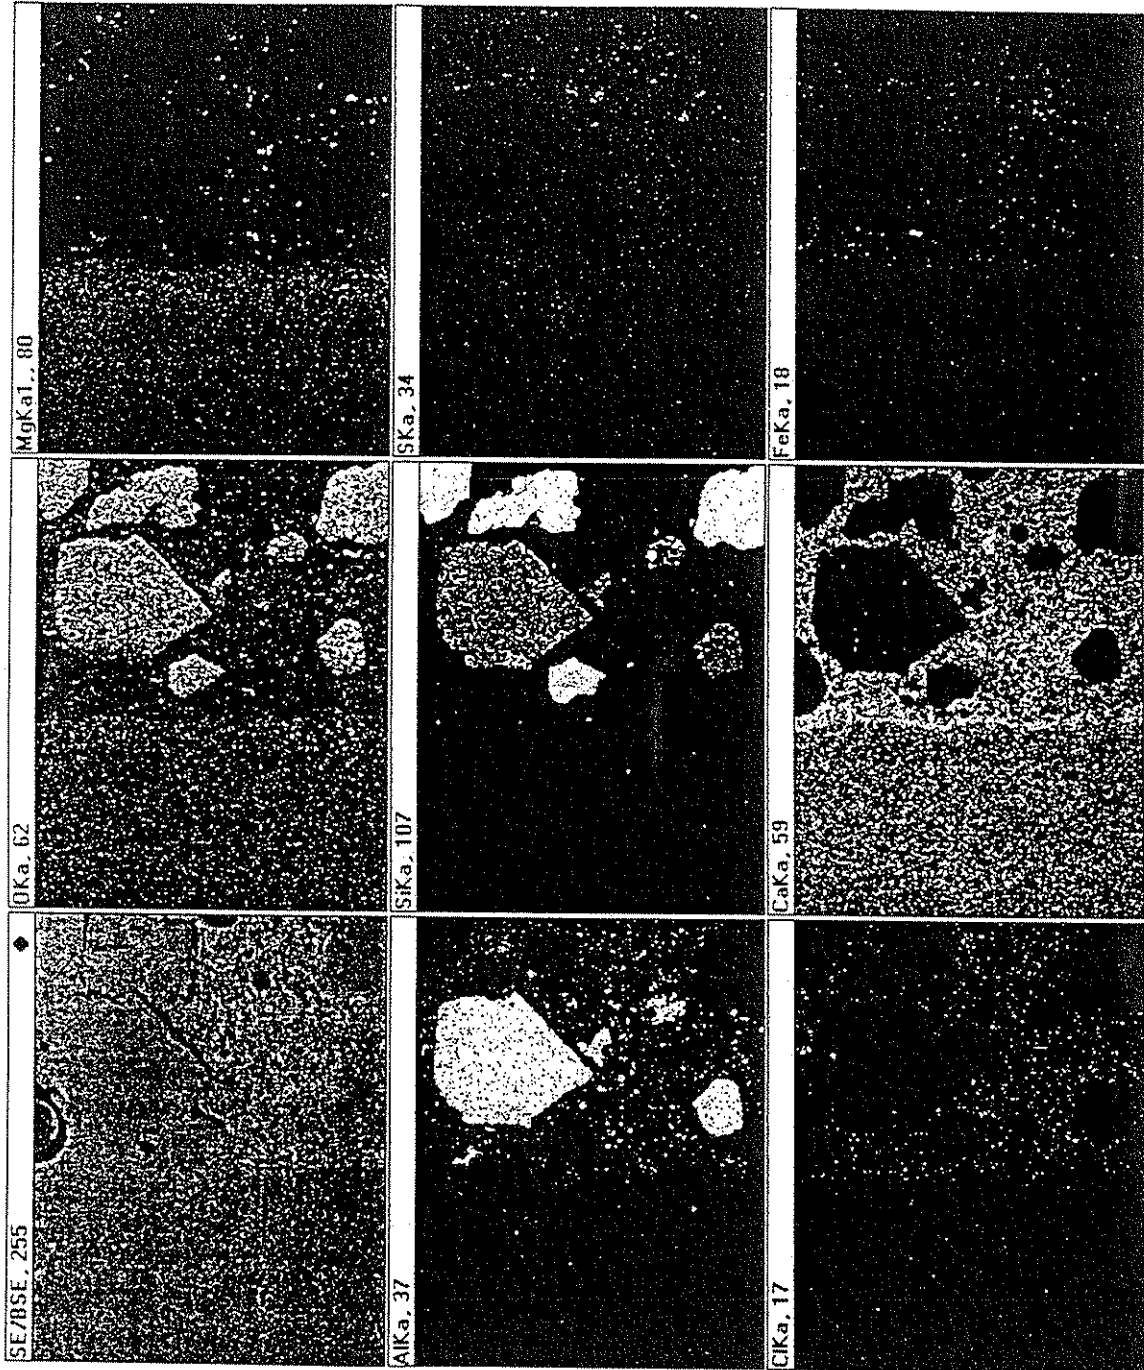
Figure 20

Fig 20. Experimental decomposition of concrete. EDAX element maps of concrete containing Paralta quarry aggregate after wet/dry cycling in Ca solution. Note the Mg increase in the outer region of the dolomite aggregate which corresponds to that found by electron microprobe analysis, Fig 19.

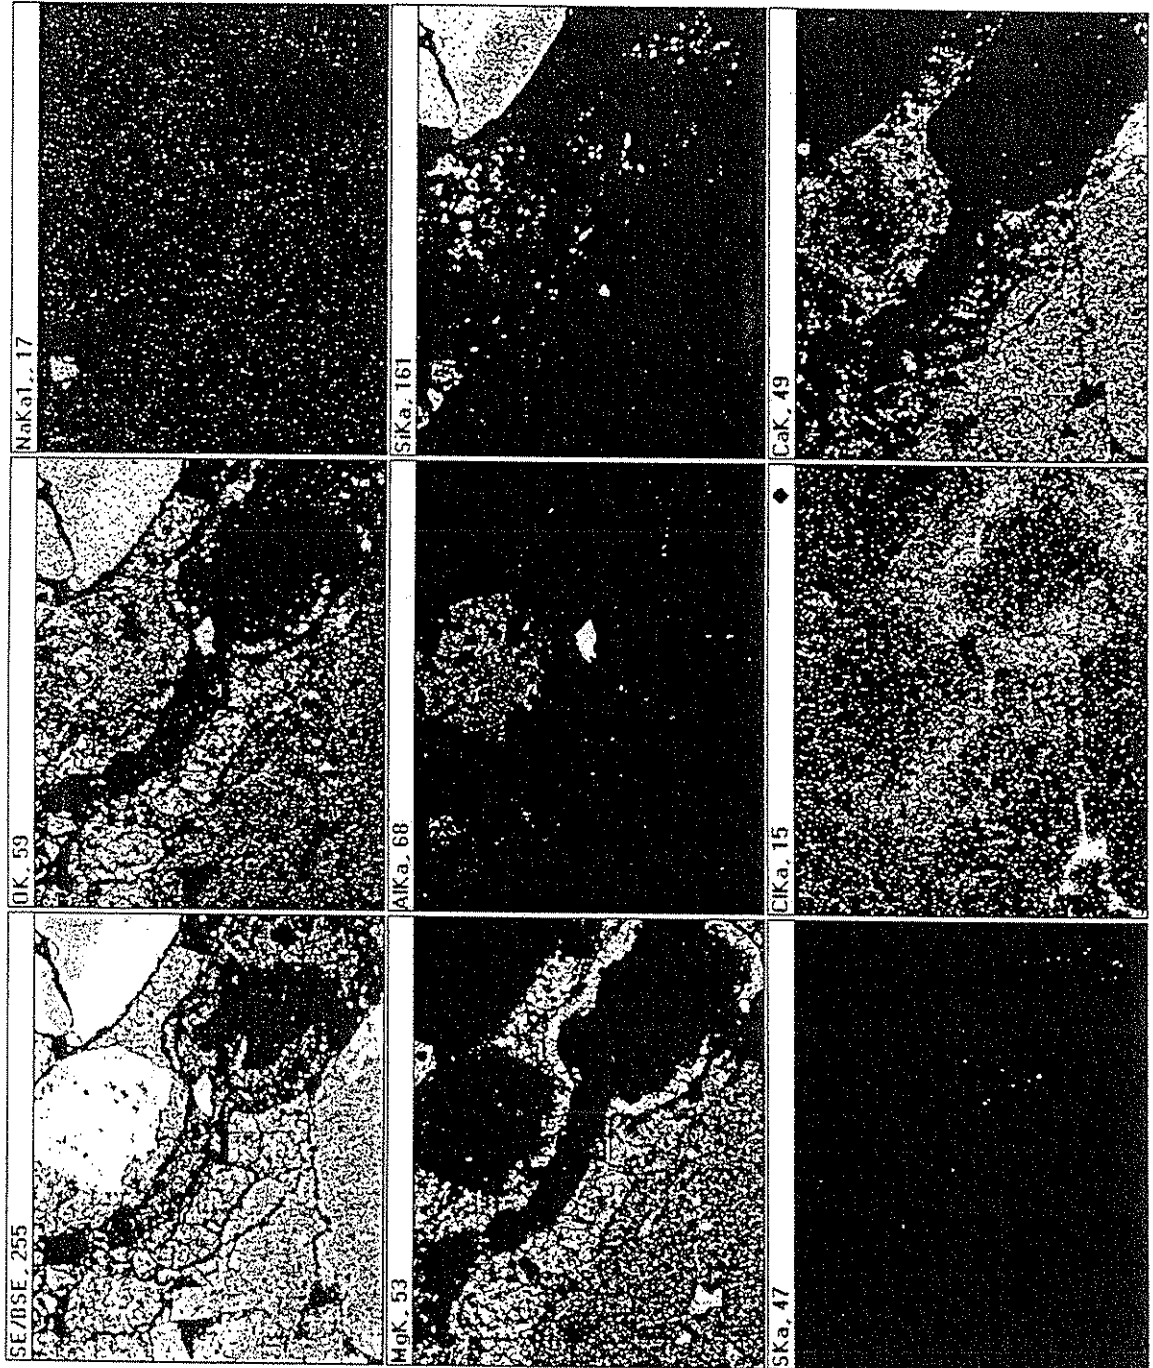
Figure 27

Fig 27. Experimental decomposition of concrete. EDAX element maps of concrete containing Mar-Jo Hills aggregate after wet/dry cycling in Mg solution. The crack-fills in dolomite are calcite, brucite, and Mg chloride. In the paste, crack and void-filling minerals of various compositions are shown by element concentrations. Calcite (Ca+O), brucite (Mg+O), Mg chloride (Mg + Cl), and possibly gibbsite (Al + O), dolomite (Ca + Mg +O), quartz (Si +O), and minor amounts of an unidentified sulfur-bearing phase. Plt XIIIa shows SEM view of area.

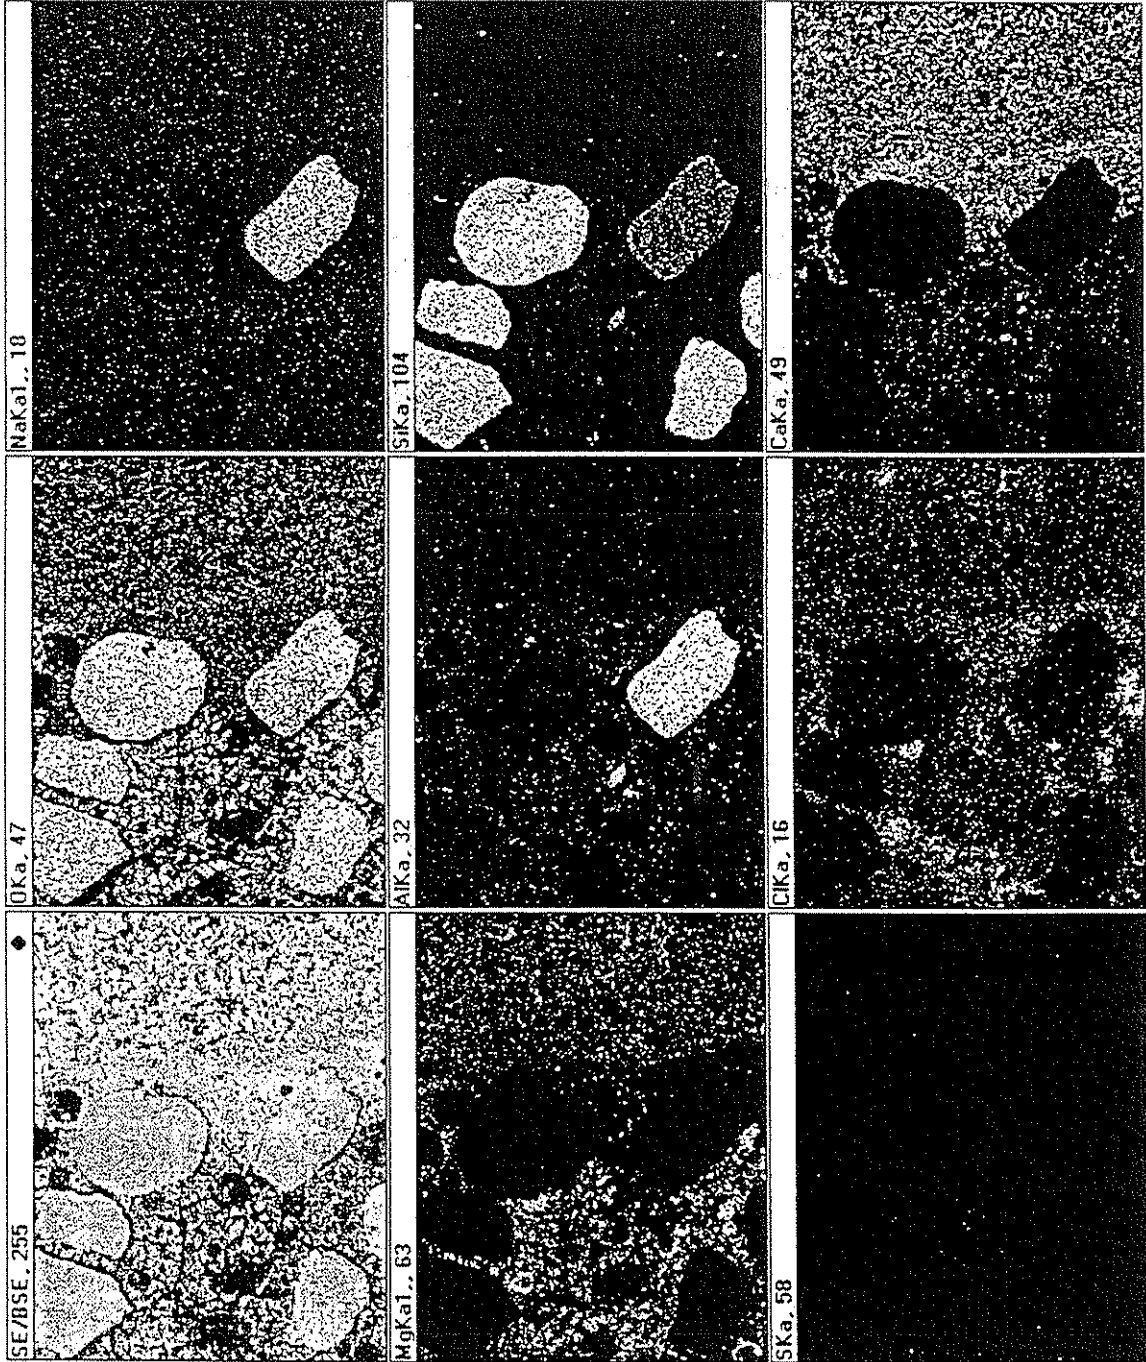
Figure 30

Fig 30. Experimental decomposition of concrete. EDAX element maps of concrete containing Garrison aggregate after wet/dry cycling in Mg solution. Interstitial voids in dolomite aggregate are filled with brucite, calcite, and magnesium chloride. In the cement there are void and crack fills of brucite, magnesium chloride, and possibly calcite. Plt XIIIe,f shows light micrographs and Plt XIIIf shows SEM view of area.
